DoD Corrosion Prevention and Control Program

Demonstration of a Liquid-Applied Liner System for Corrosion Protection and Rehabilitation of Wastewater System Structures

Final Report on Project F11-AR24

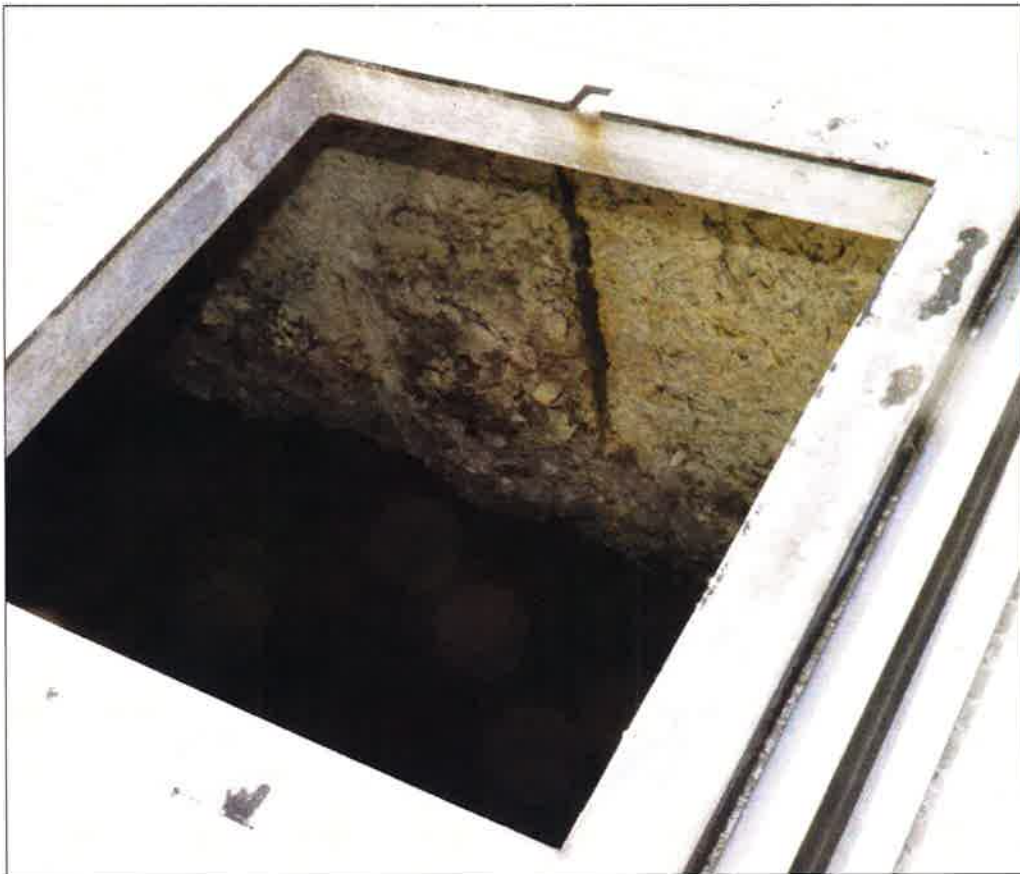
Figure 1. Example of MICC-deteriorated concrete in Fort Bragg system.

Corrosion damage typical for wastewater treatment system components is shown in Figure 1 and Figure 2. These pictures are consistent with the effects of MICC, including exposure and corrosion of concrete reinforcement steel. The chemical structure of polyurea in the demonstrated product cures to form a barrier coating that resists corrosion. The foam layer provides a substrate for an additional coat of liquid polyurea, which provides additional standoff between coated concrete and effluent.

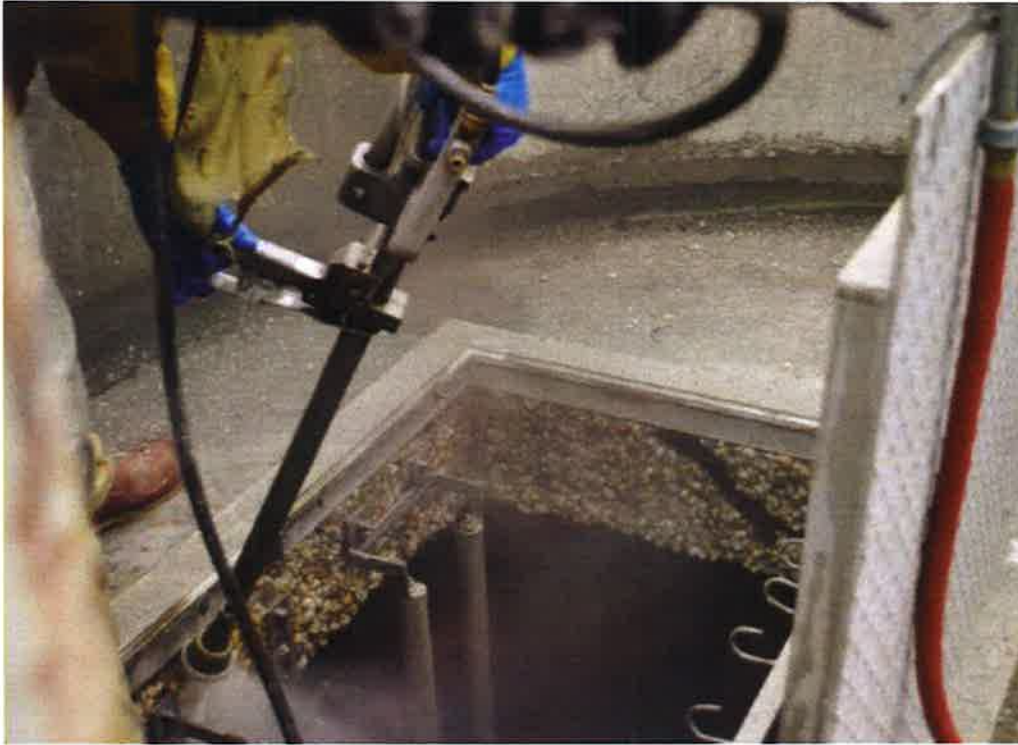
Figure 4. Hydro-blasting a lift station.

After initial washing, all surfaces in the lift station were hydroblasted at up to 40,000 psi (Figure 4). Note that the concrete deterioration visible in the figure was caused by MICC, not the force of the hydroblasting procedure. This high-pressure washing ensures thorough cleaning of all surfaces, including removal of loose mortar and debris as required by the SpectraShield application instructions. Manholes were pressure washed, but not hydroblasted. Additionally, the steel collars of the manhole entries were cleaned and descaled (Figure 5).

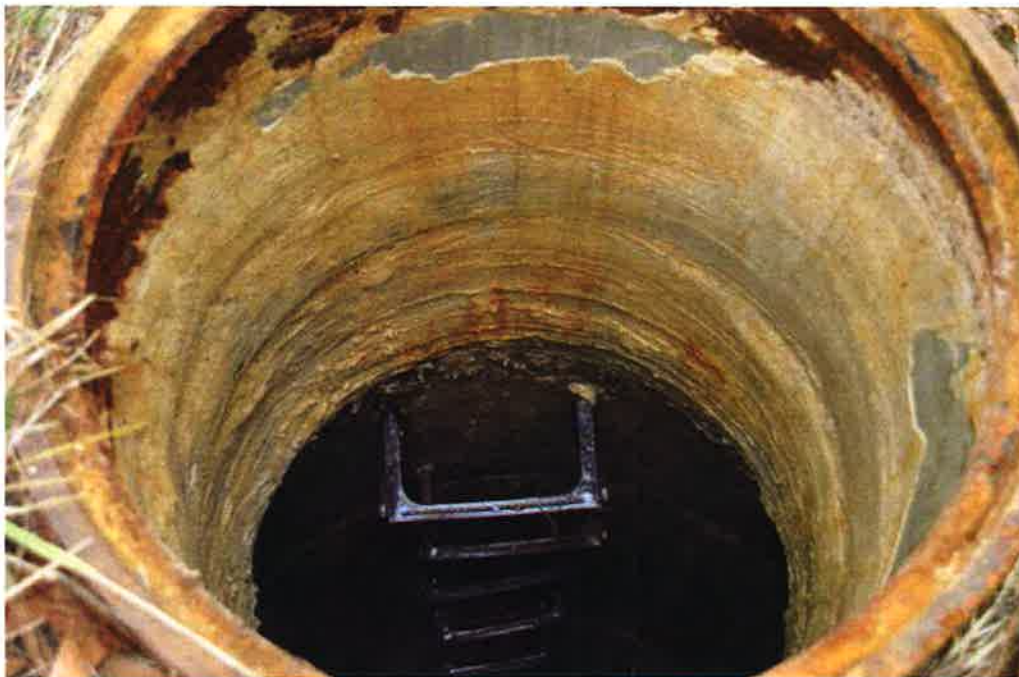
Figure 6. Ladder rungs to be removed.

Many of the manholes were equipped with steel ladder rungs (Figure 6) that were originally installed for access purposes but are no longer needed. During surface preparation, these rungs were removed with permission to improve the lining results. Generally, rungs should be removed when they are unsafe or not required by applicable codes or local policies. However, when appropriate, permanent access ladder rungs may be left in place before application of the SpectraShield system.

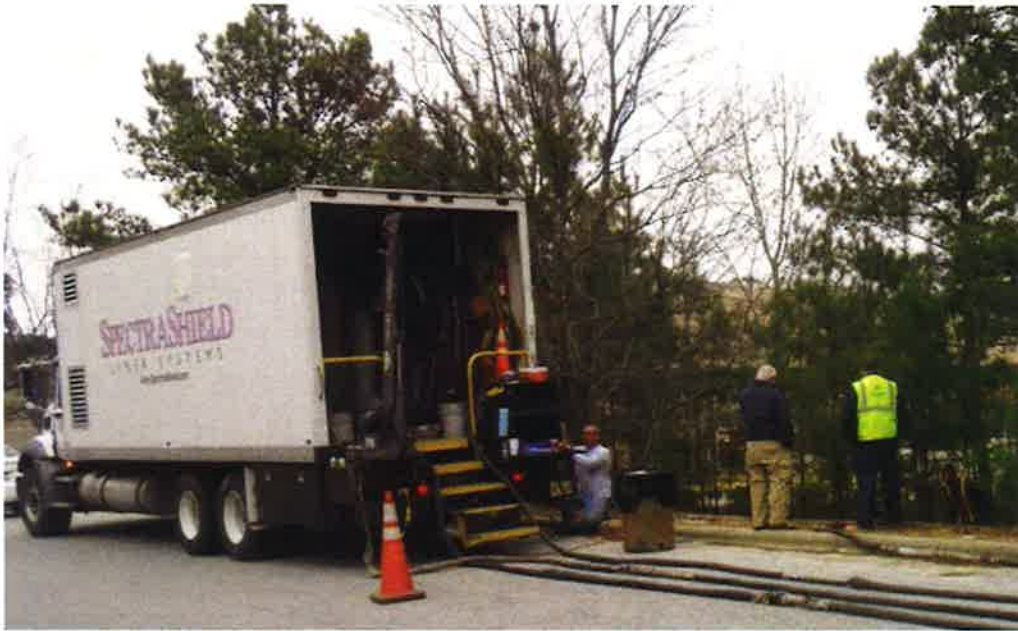
Figure 7. Specially equipped application-support vehicle.

heated up to 150 °F using Graco-Guzmer H-20/35 Pro-Dual Plural Component Proportioning Unit spray equipment housed in a purpose-modified truck for onsite portability (Figure 7). In addition to the coating application equipment, the truck is equipped with air compressors for supplied breathing air, and blowers to ventilate the confined spaces that are to be coated.

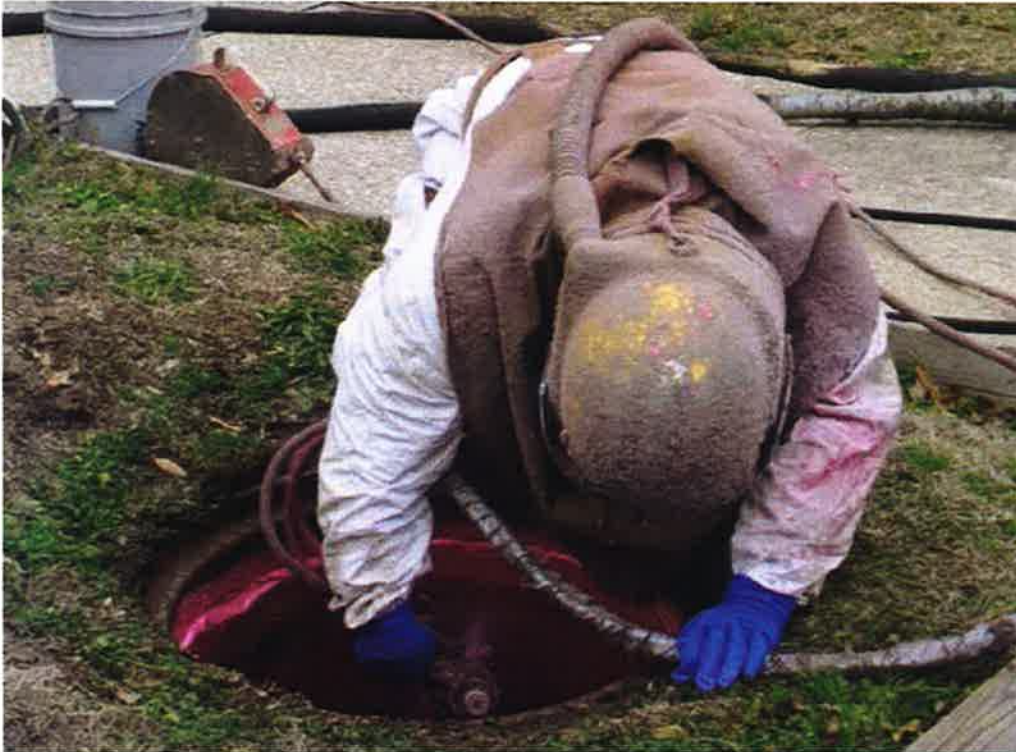
Figure 8. Applying initial barrier coat.

The first polyurea coating is applied (Figure 8) to a minimum recommended thickness of 75 mils. The material cures in a few seconds and can immediately be coated with the foam. The foam is a two-component polyurethane closed-cell foam formulation (isocyanate and polymeric resin) that is applied at a 1:1 ratio with the plural-component proportioning unit. The equipment must be heated to a minimum temperature of 125 °F at the gun. Like the polyurea, the foam is also a 100% solid, zero-VOC formulation. The foam is applied at a recommended thickness of 350 mils to provide adequate cushion protection from impact damage and to add structural support to the combined liner system. Figure 9 shows the applicator applying the foam over the initial barrier coat in a manhole. The foam application is followed by the final application of the barrier coating to a recommended 75 mils thickness. Once the final coating is applied, it is date stamped (Figure 10) for reference purposes during inspection and maintenance. Figure 11 shows a completed manhole. No difficulties were

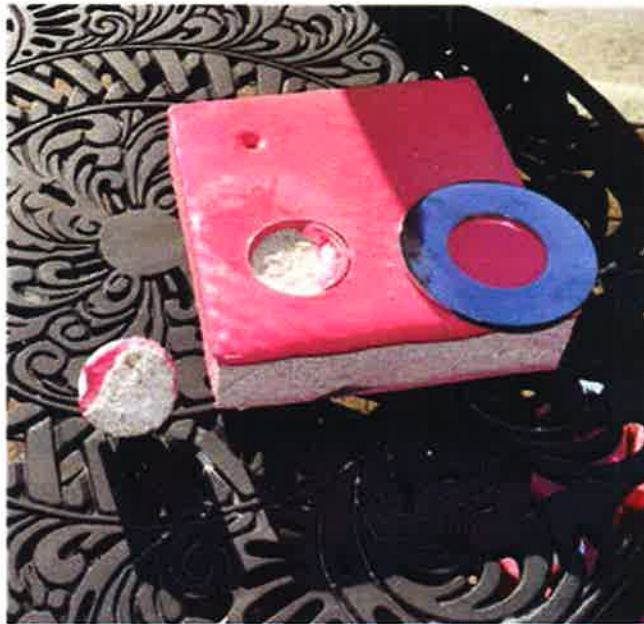
Figure 12. Concrete specimen C-1 after time-zero test.

The coating-adhesion tests were performed by Mandaree in accordance with ASTM D7234. The first adhesion tests were executed at the conclusion of the liner application work using an Elcometer 106/6 concrete adhesion tester. The results of Test 1 are shown in Table 1. Two post-test coupons are shown in Figure 12 and Figure 13. The contractor test report is included in Appendix C.

Coupon	Coating	Failure force (PSI)	Failure mode	Failure area (% of test surface)
C-1, concrete	Primed	410	Substrate Failure	90
RB-1, red brick	Primed	530	Glue Failure	90
B-1, sandy red brick	Unprimed	550	Substrate Failure	98
RB-2, red brick	Unprimed	260	Substrate Failure	99
B-2, sandy red brick	Primed	450	Substrate Failure	98
