Evaluating Spectrashield Coating for Concrete Manhole: Hydro-Static Pressure Test

**SPECTRASHIELD
Coating Materials
(Wet Concrete Coating)**

C. Vipulanandan and K. Gebreselassie

**Center for Innovative Grouting Materials and Technology (CIGMAT)
Department of Civil and Environmental Engineering
University of Houston
Houston, Texas 77204-4003
Report No. CIGMAT/UH 2014-11-2**

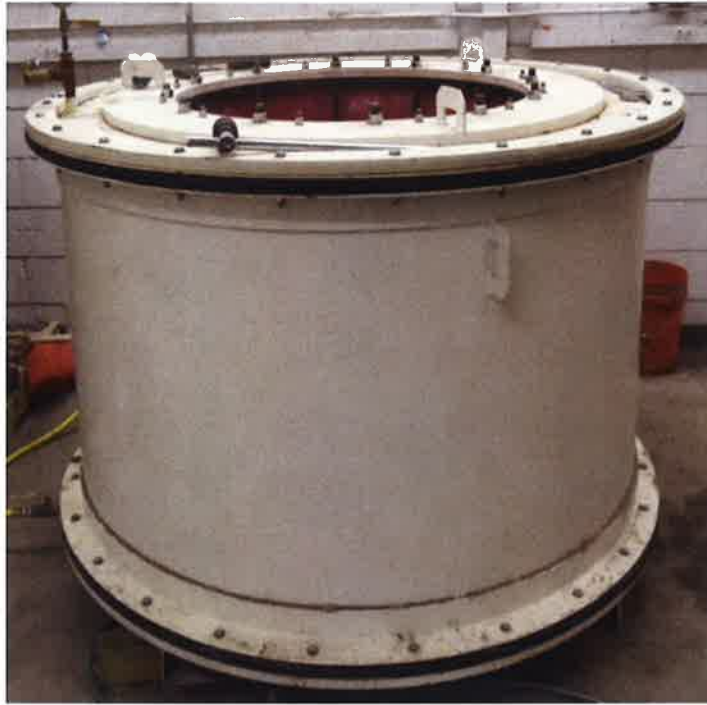
(a) Elevation

(b) Plan

Figure 2. Test Chamber

The coated concrete manhole was placed in a specially designed test chamber for testing manholes (Fig 2). The hydrostatic pressure was applied from outside the manhole in incremental steps to the coated concrete manhole. The coating was inspected for leaks and the distance between the steel rod and coating were measured to an accuracy of 0.001”.

1. The concrete manhole was placed in a steel testing chamber. Water swelling agent was applied on the bottom and top ring of the concrete manhole to avoid leakage of water from the ends.

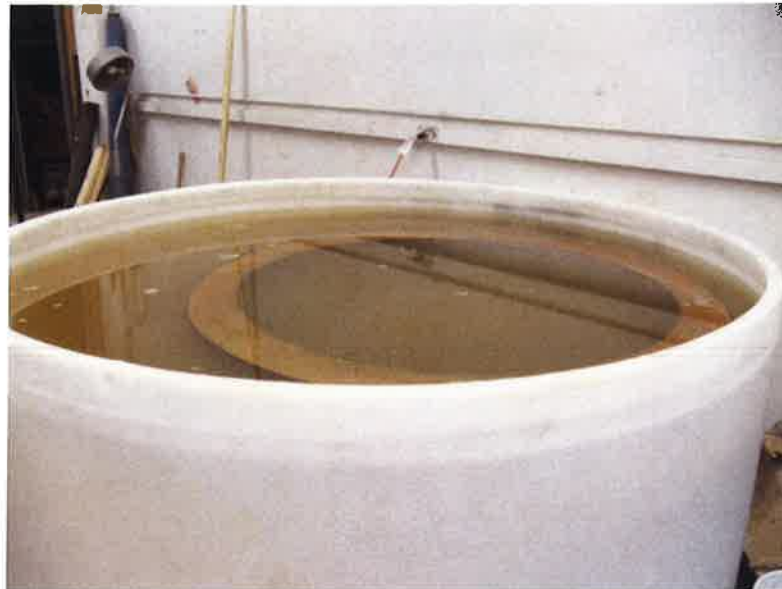
Figure 4. Saturation of manhole

The concrete manhole was submerged into a water tank (Fig 4) for 7 days before applying the coating.

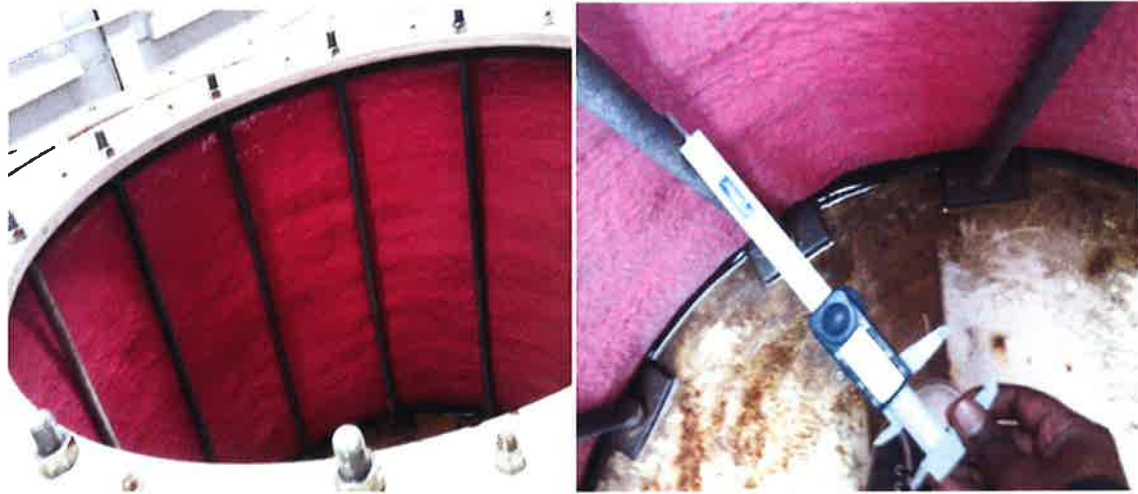
(a) View of the coating measurement

(b) Vernier caliper for deformation

Figure 6. Coating at hydrostatic pressure of 30 psi

2. The outside chamber was filled with water.
3. Initial readings of coating with respect to the steel rods were taken using a vernier caliper.
4. The hydrostatic pressure was increased from 0 to 5 psi on the 2nd day.
